JP Research, Inc.

Re: Keith Yaeger vs. Subaru of America, Inc.

At your request, I have performed an evaluation and analysis of technical issues related to the matter captioned Keith Yaeger vs. Subaru of America, Inc. Specifically, I was asked to review and analyze documents relating to the in use oil consumption of the Subaru FB engine family as well as address specific concerns that have been raised in this matter. My analysis is based upon the available information provided in this matter and my knowledge and experience in the fields of powertrain and chassis system design, performance, and operation, engine and powertrain testing and development, and on road vehicle performance evaluations.

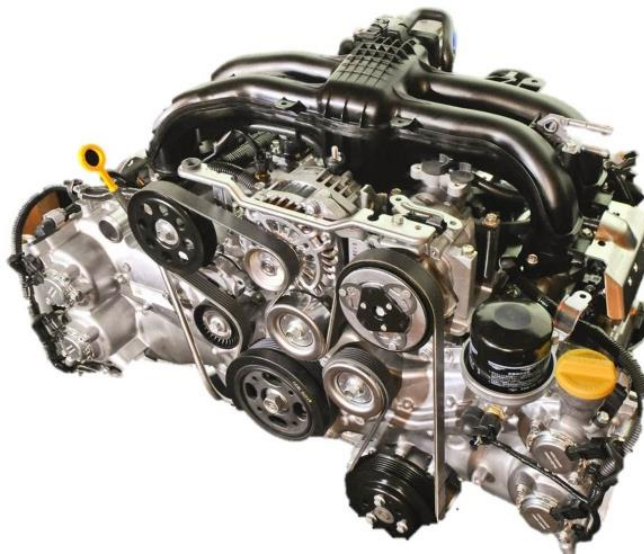
Subaru FB Engine
